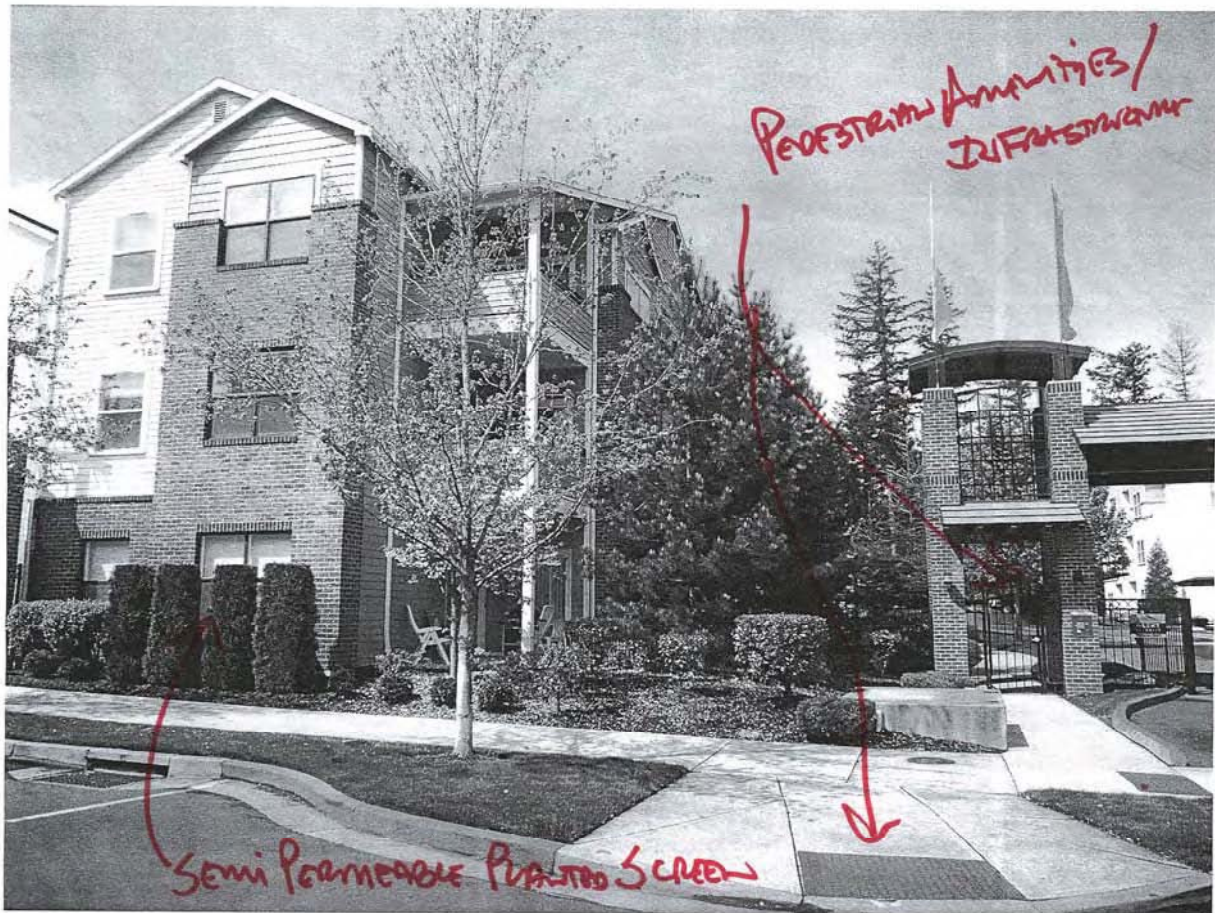
- Pedestrian amenities/infrastructure and the semi-permeable planted screen were observed.

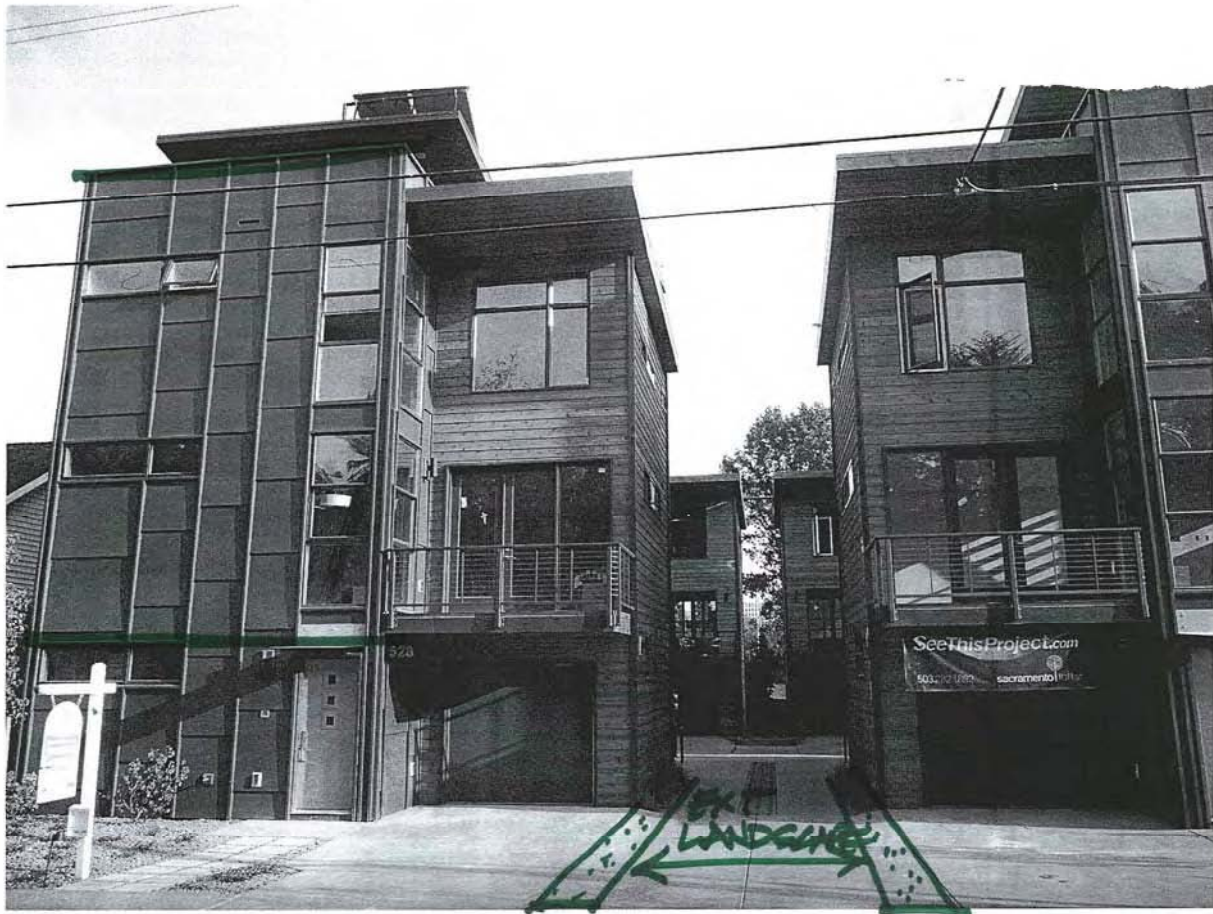
- MULTI FAMILY DEVELOPMENTS .

- RECREATION AREAS CONNECTION TO BOTH BLDG & COMMUNITY (STREET)
- FENCING & SCREENING REQ
- PORCH CONNECTIVITY (FULLY SCREENED V SC

\* - CENTRAL COURT TRIP \*

- The recreation areas should connect to both the buildings and the community (or street). Fencing and screening should be required.
- The landscape should also be extended.

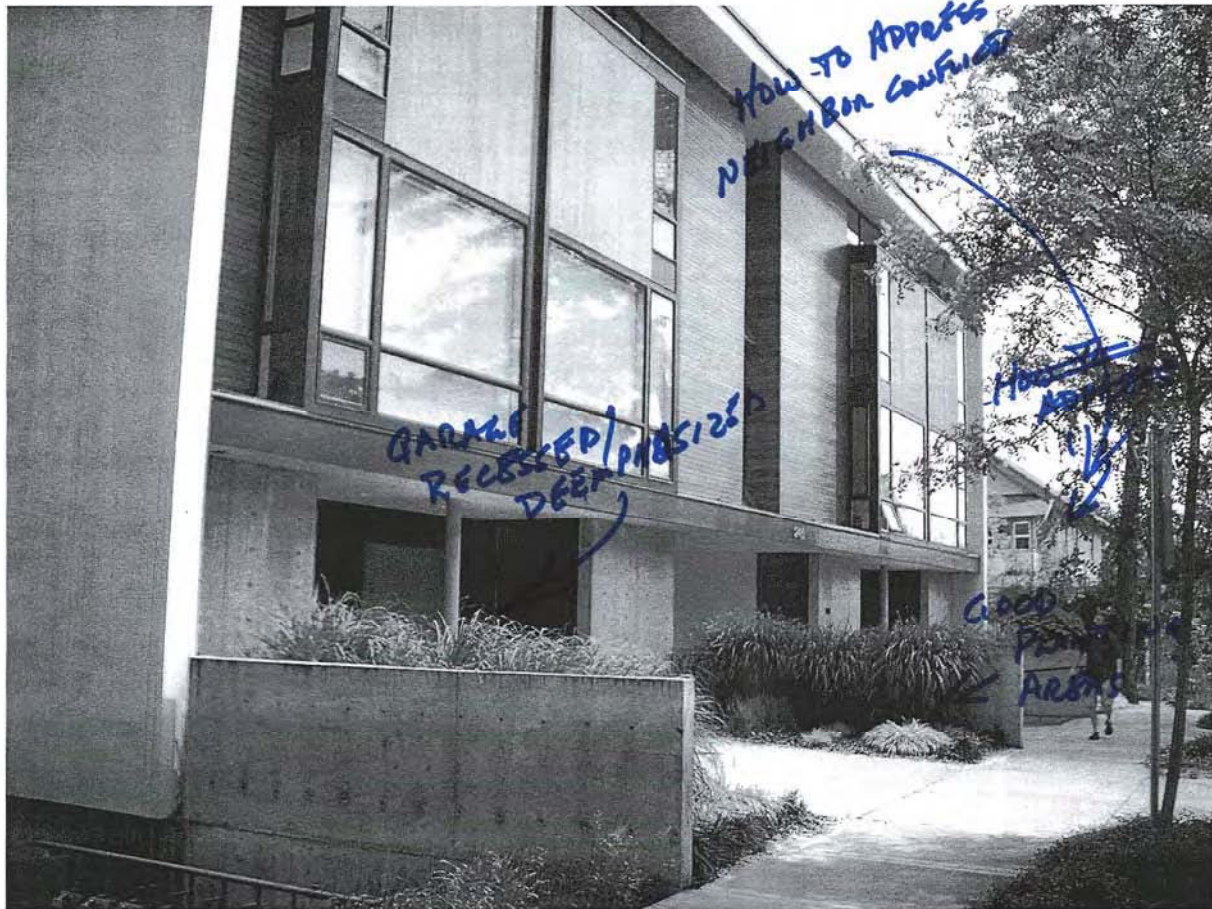
- There are good planting areas.
- The garage is recessed, which deemphasizes the garage.
- The buffer between the two buildings should be addressed to avoid neighbor conflicts.

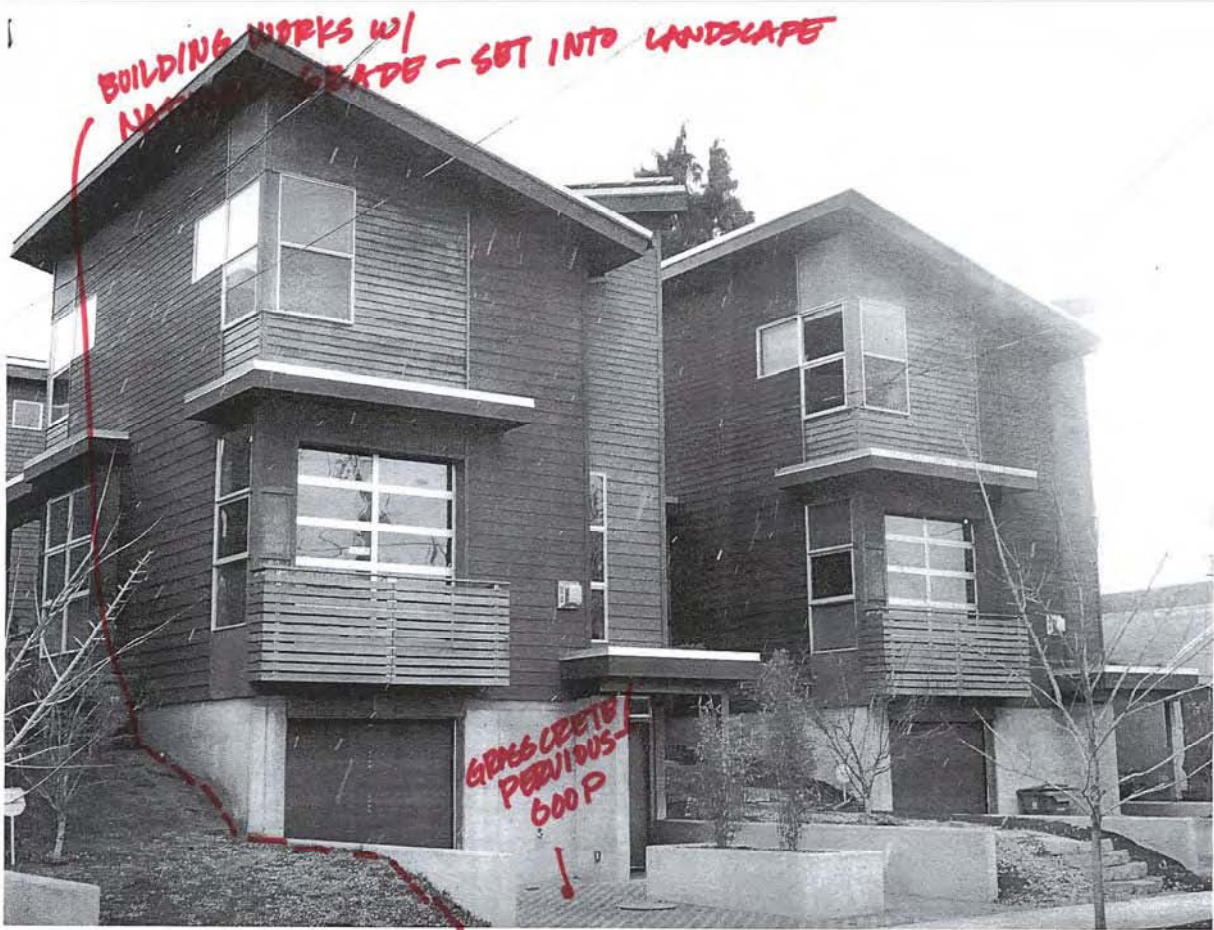
- The building works with the natural grade since it is set into the landscape.
- The use of grass-crete/pervious paving is another positive aspect.

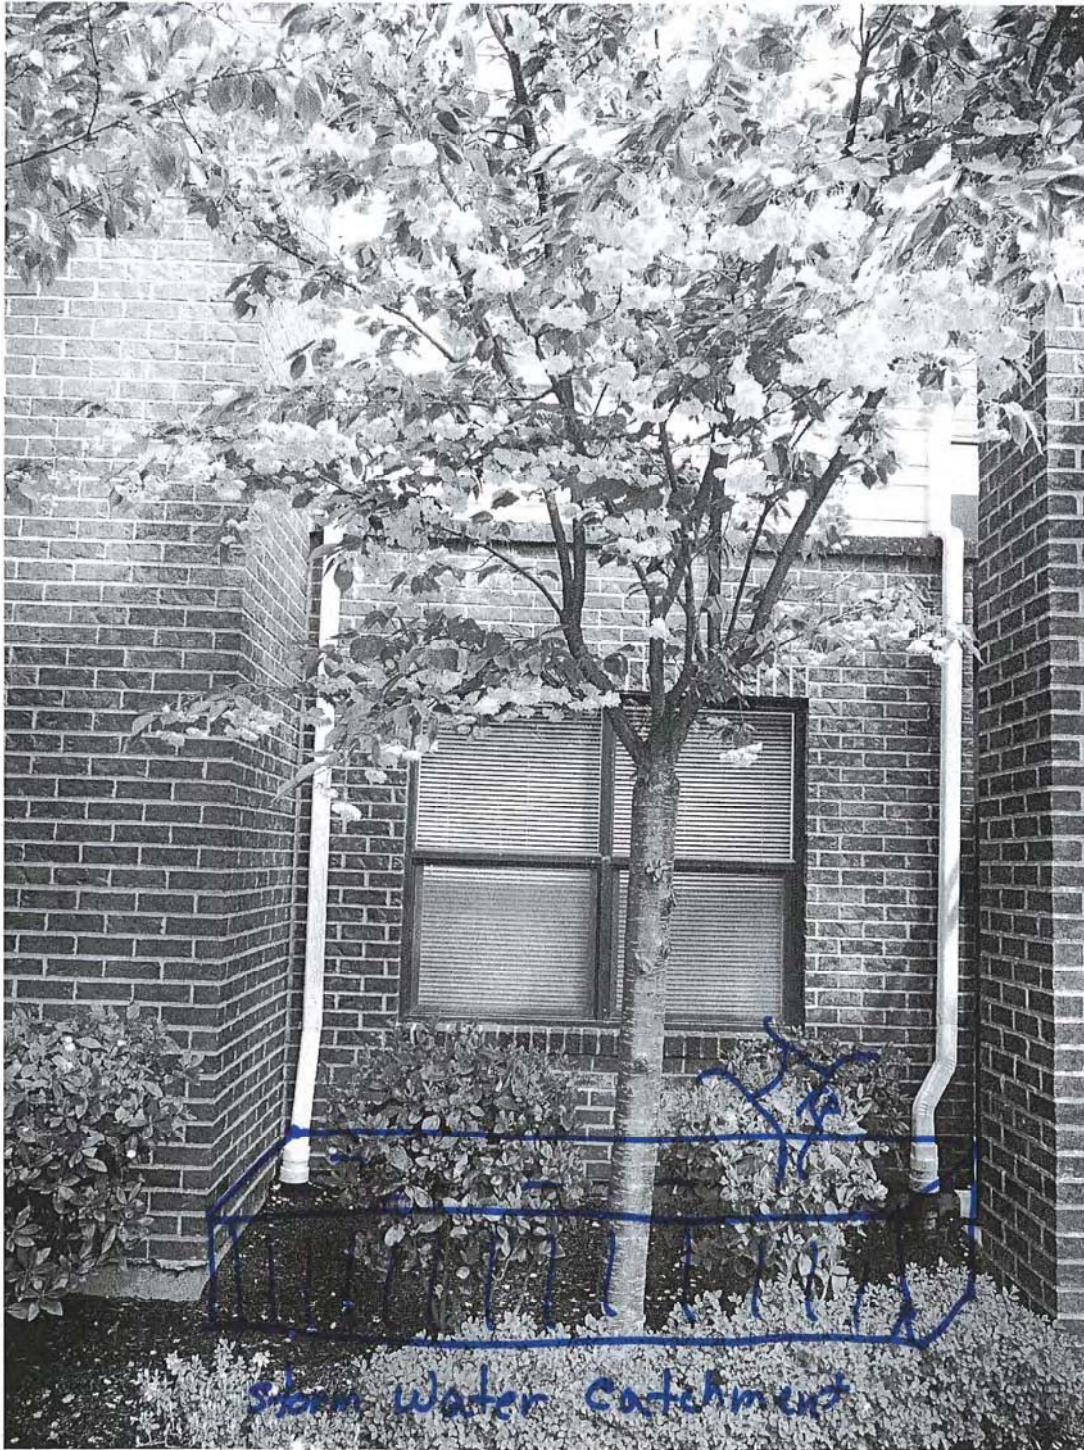
- A stormwater catchment could be incorporated.

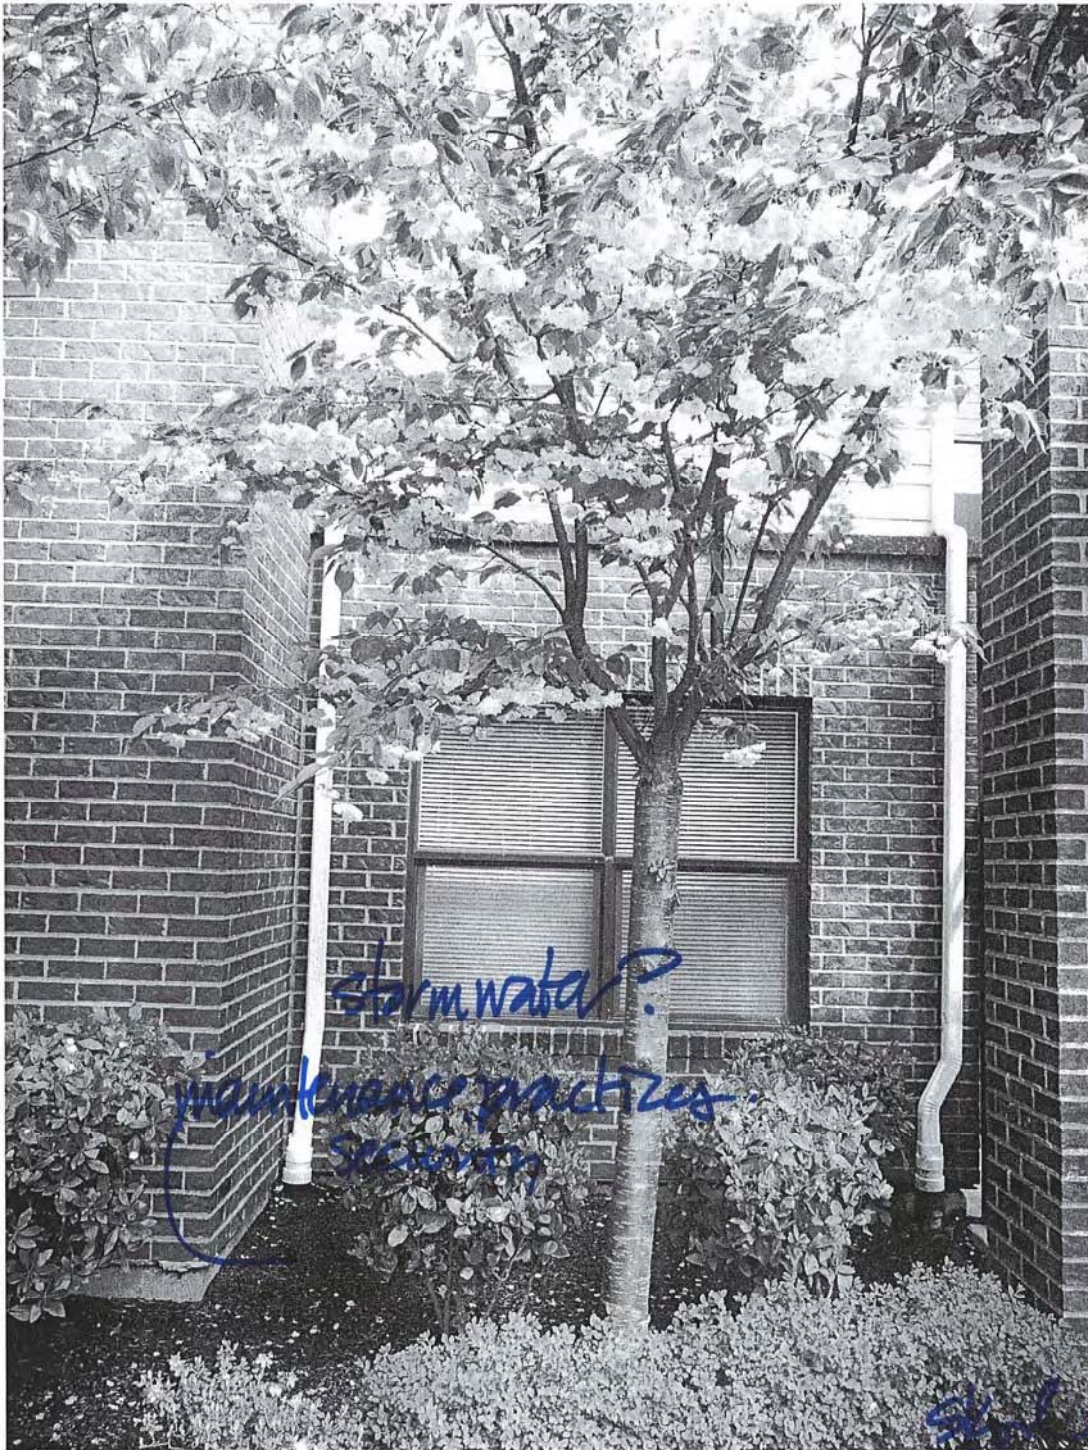
- This may be a good place for some type of stormwater treatment as well as maintenance practices and security.

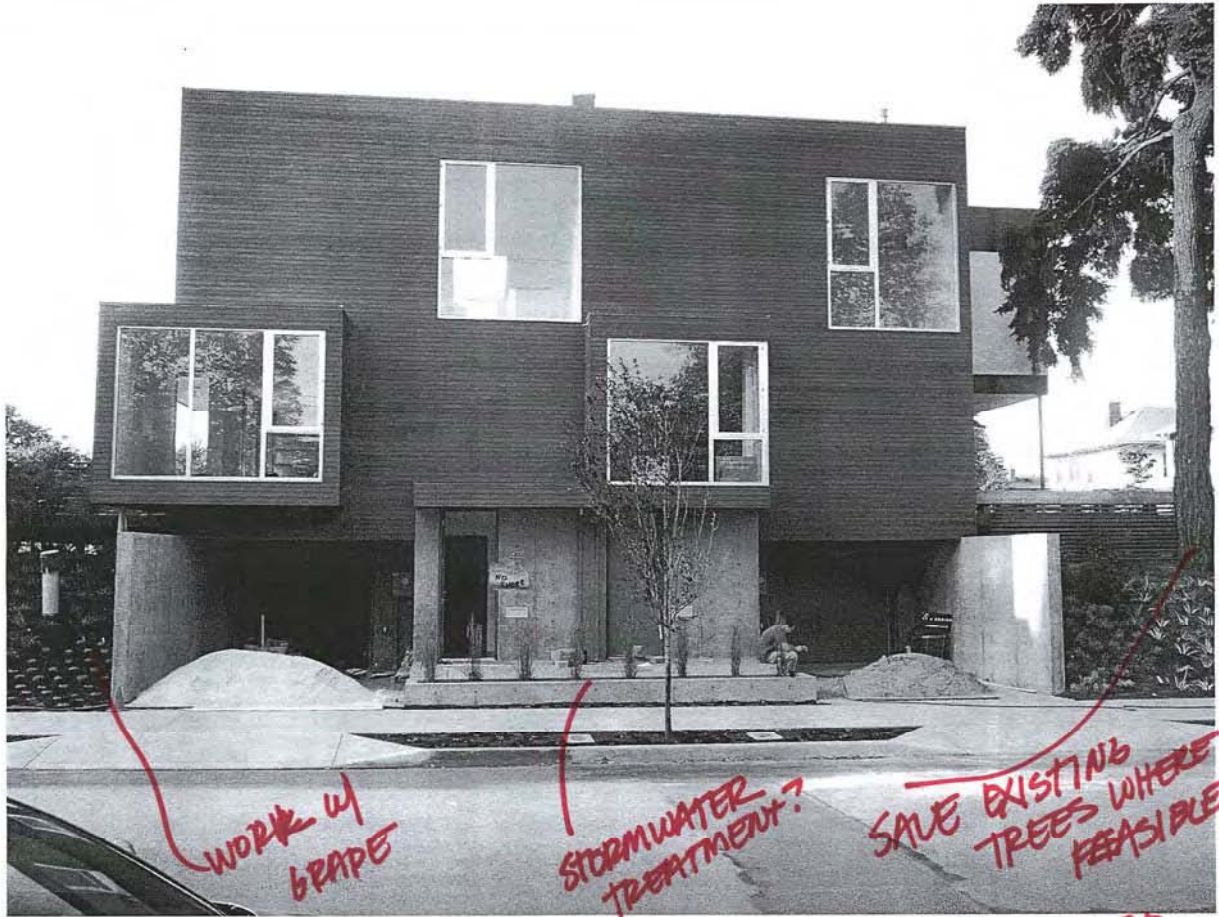
- The building should work with the grade and perhaps should incorporate some stormwater treatment.
- The existing trees should be saved where feasible.

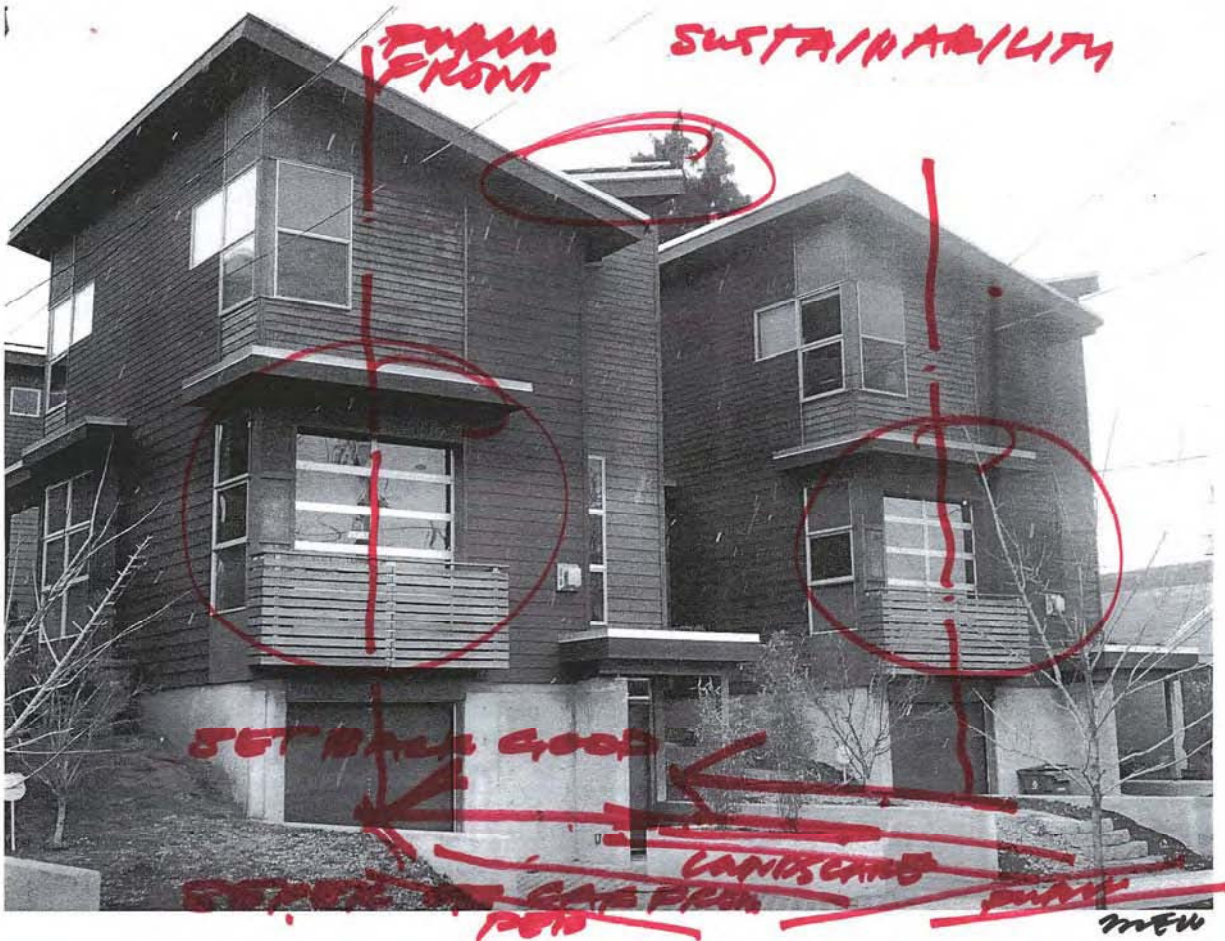
- The setback is good.
- The solar panel on the roof is also good since it is sustainable.
- The site should have additional landscaping.
- The vehicular space should also be separate from the pedestrian space.

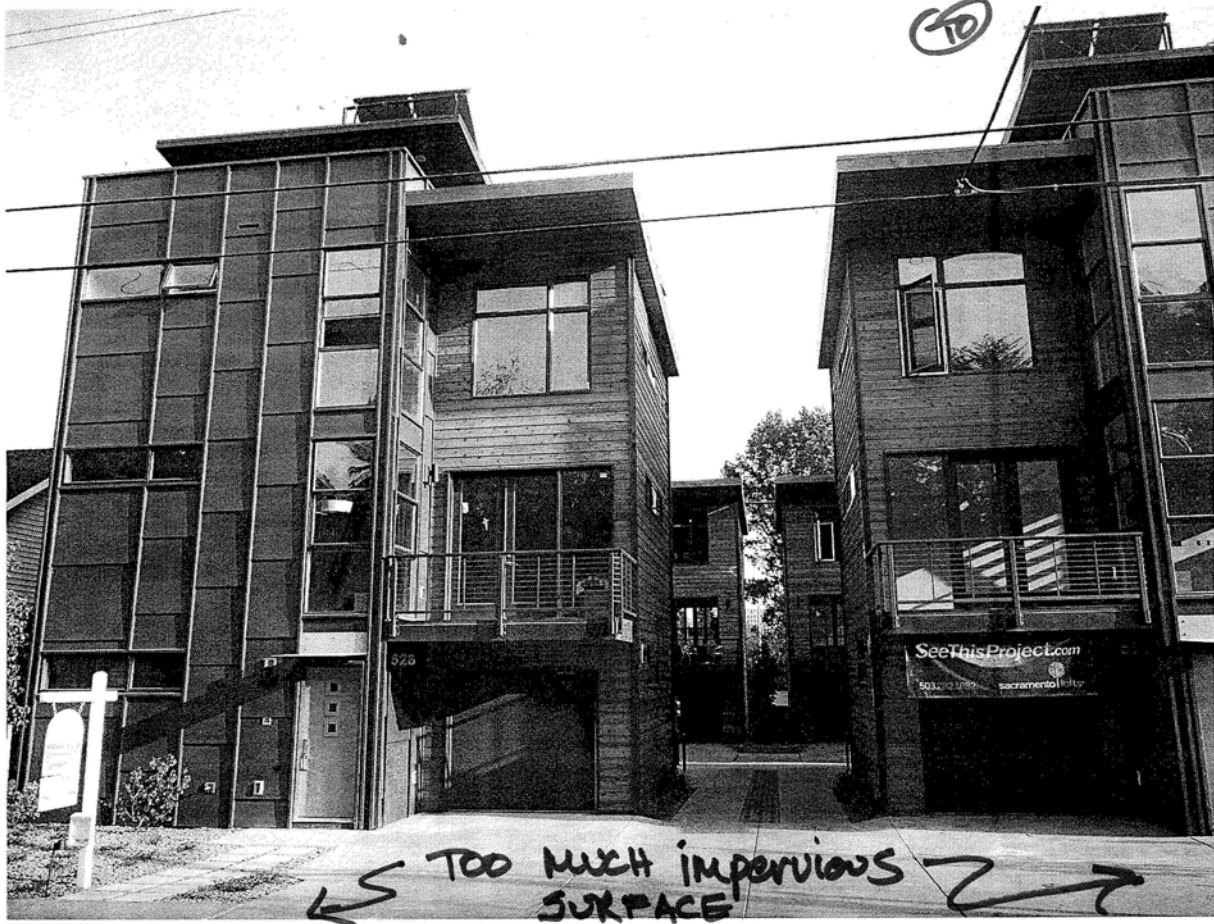
- There is too much impervious surface in this site.

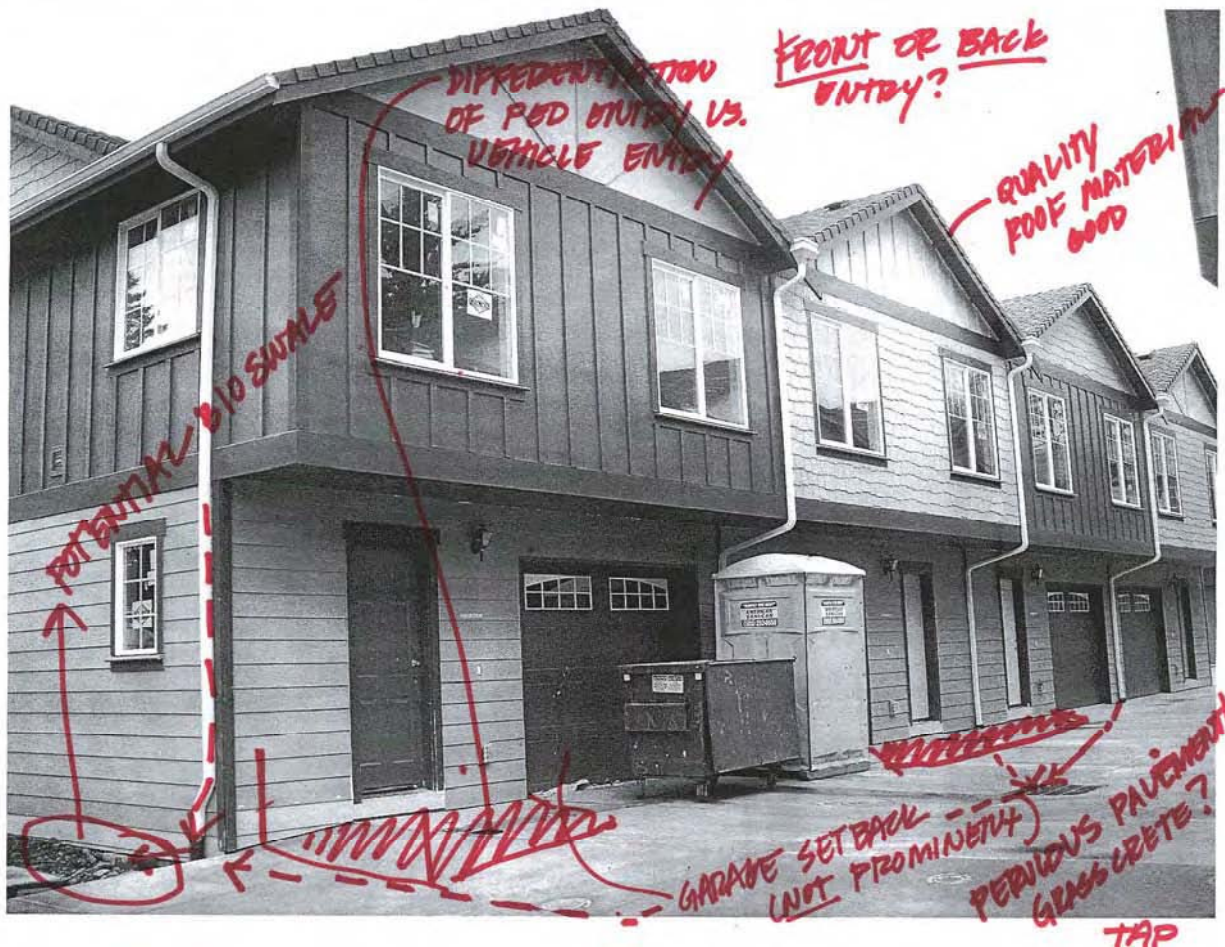
- There is potential for a bioswale.
- There should be differentiation between the pedestrian entry and the vehicle entry.
- It is unclear as to if this image depicts the front or rear entry.
- The use of quality roof materials is good.
- The garage setback is not prominent.
- Perhaps pervious pavement/grass-crete should be utilized.

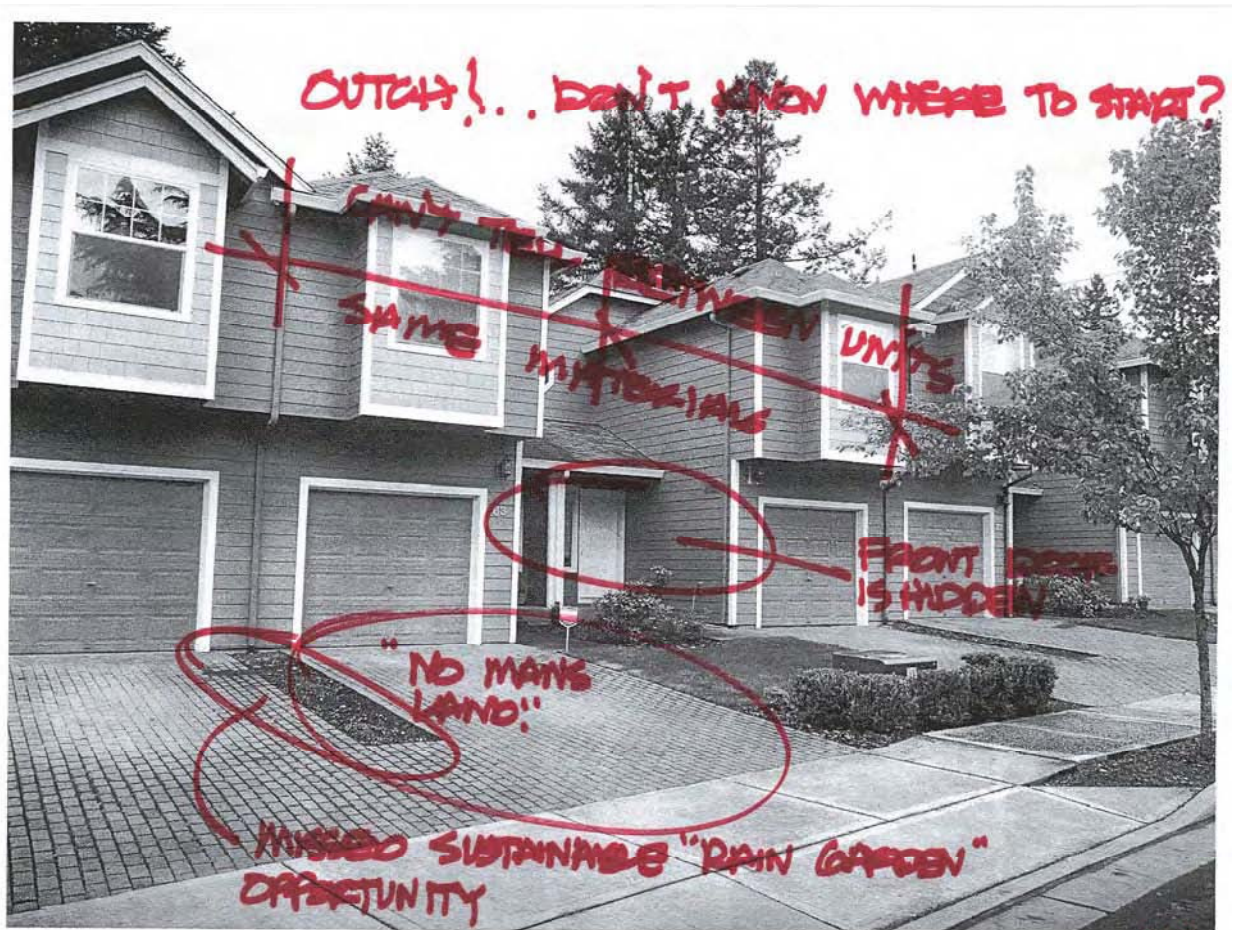
- It is difficult to detect a difference between the two units pictured since the same materials are used for both.
- The front door is hidden.
- The vehicular space is a “no mans land.”
- There is also a missed opportunity for a sustainable “rain garden” in the vehicular space.

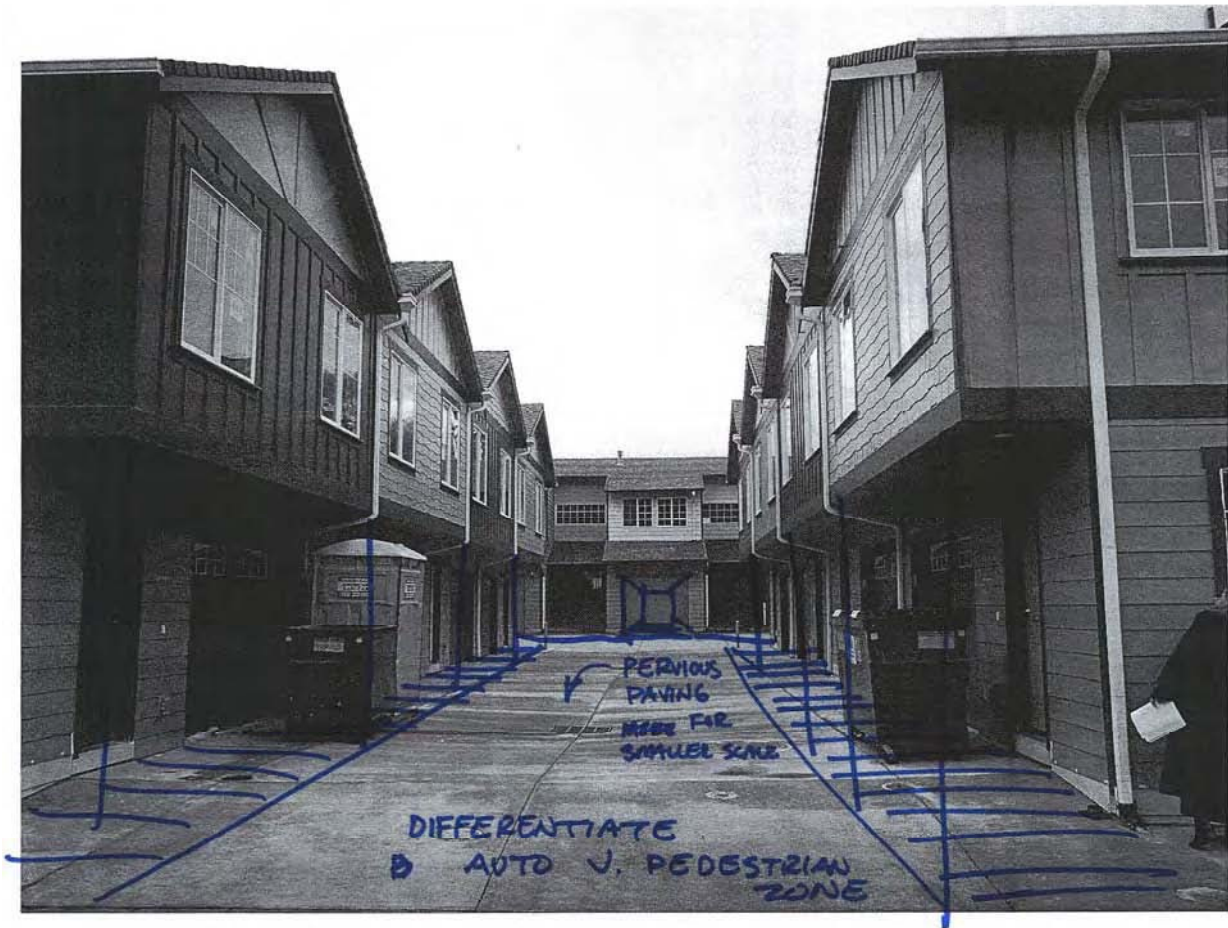
- There should be differentiation between the auto and pedestrian zone.
- Pervious paving should be used here for a smaller scale.

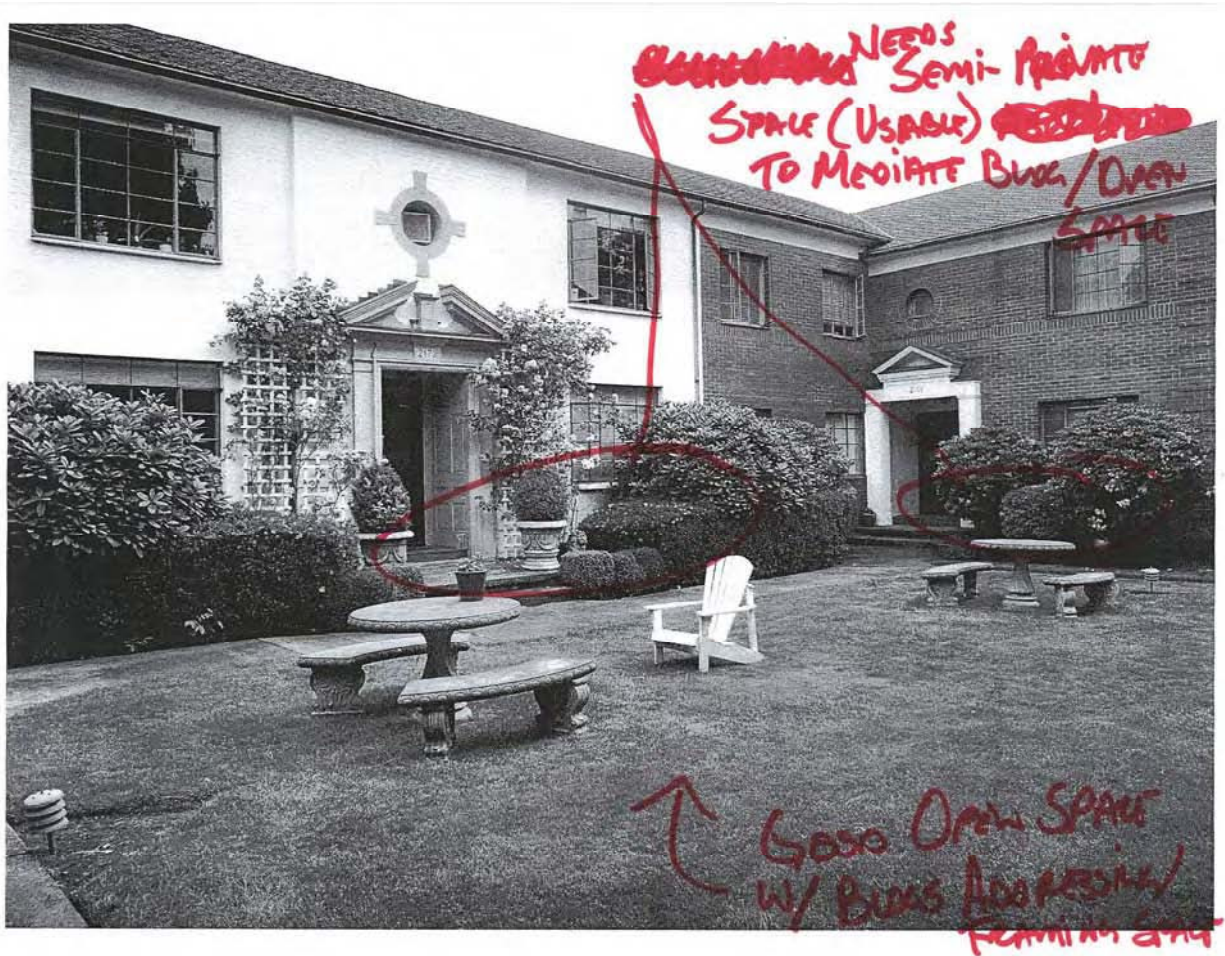
- This site needs the addition of a semi-private space that is usable to mediate the building and open spaces.
- This is a good example of open space since the buildings address/frame the space.

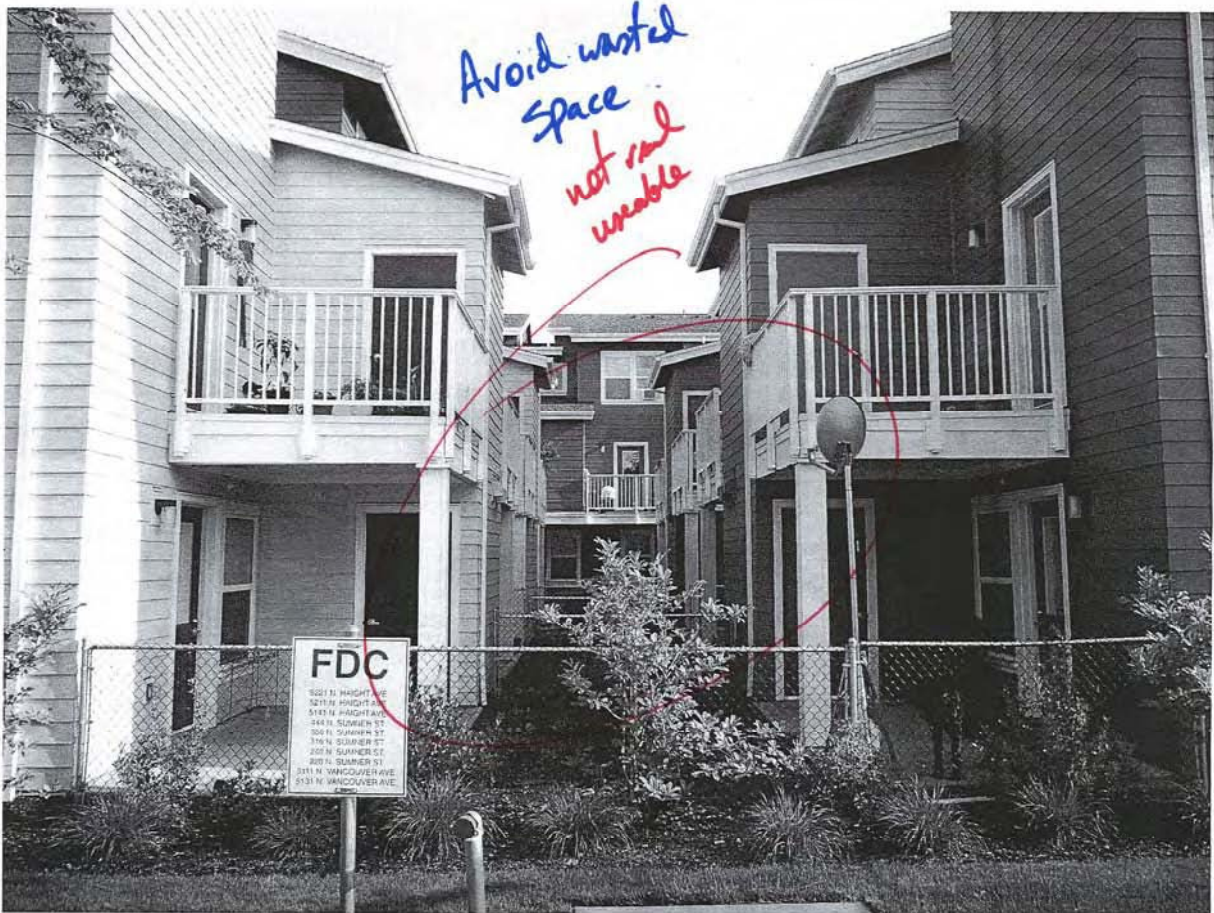
- Avoid wasted space.
- The space indicated is not really usable.

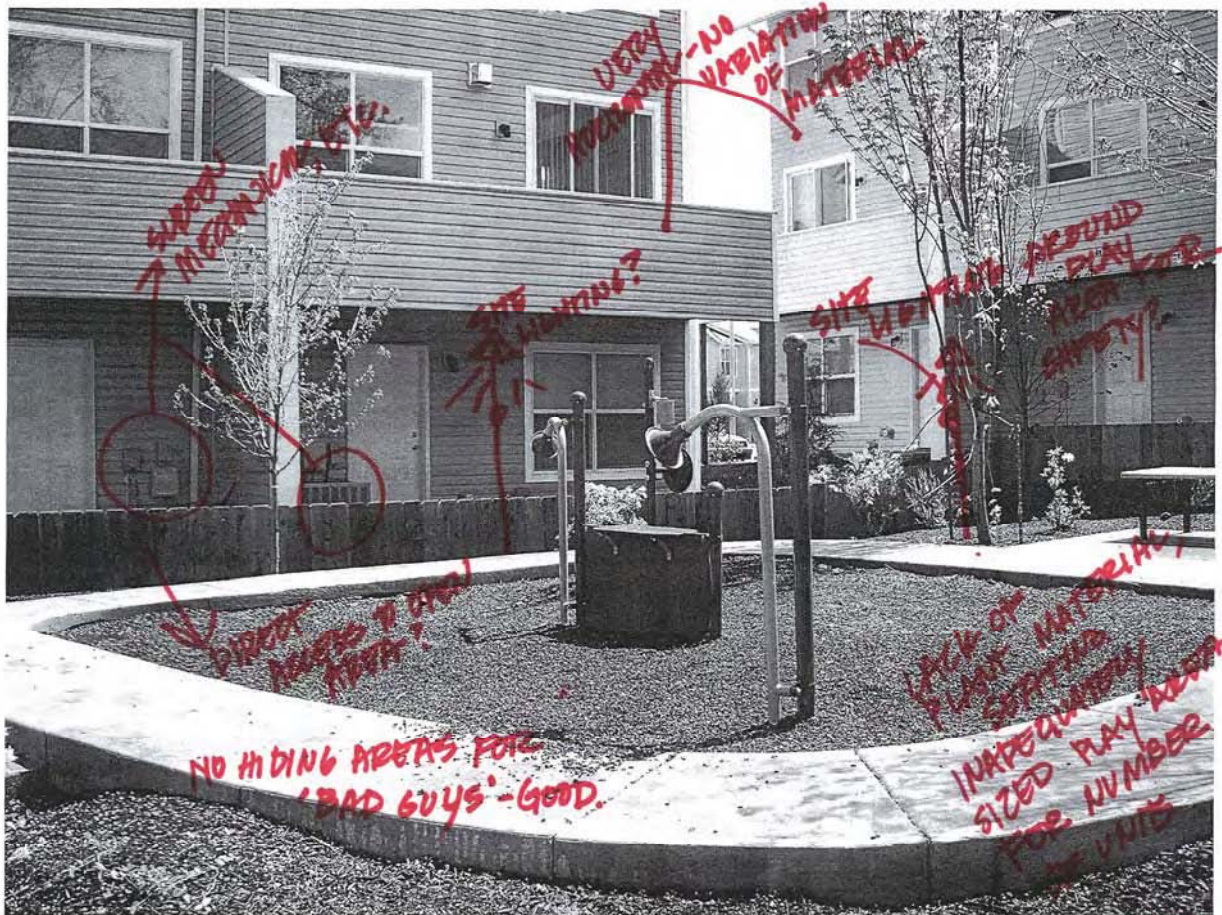
- The mechanical equipment should be screened.
- The materials used for the balconies are very horizontal with no variation of materials.
- There should be more site lighting around the play area for safety.
- It is unclear whether there is direct access to the open area from the private residential area.
- There is a lack of plant material and the play area is inadequate in size for the number of units present.
- There are no hiding areas for “bad guys,” which is good.

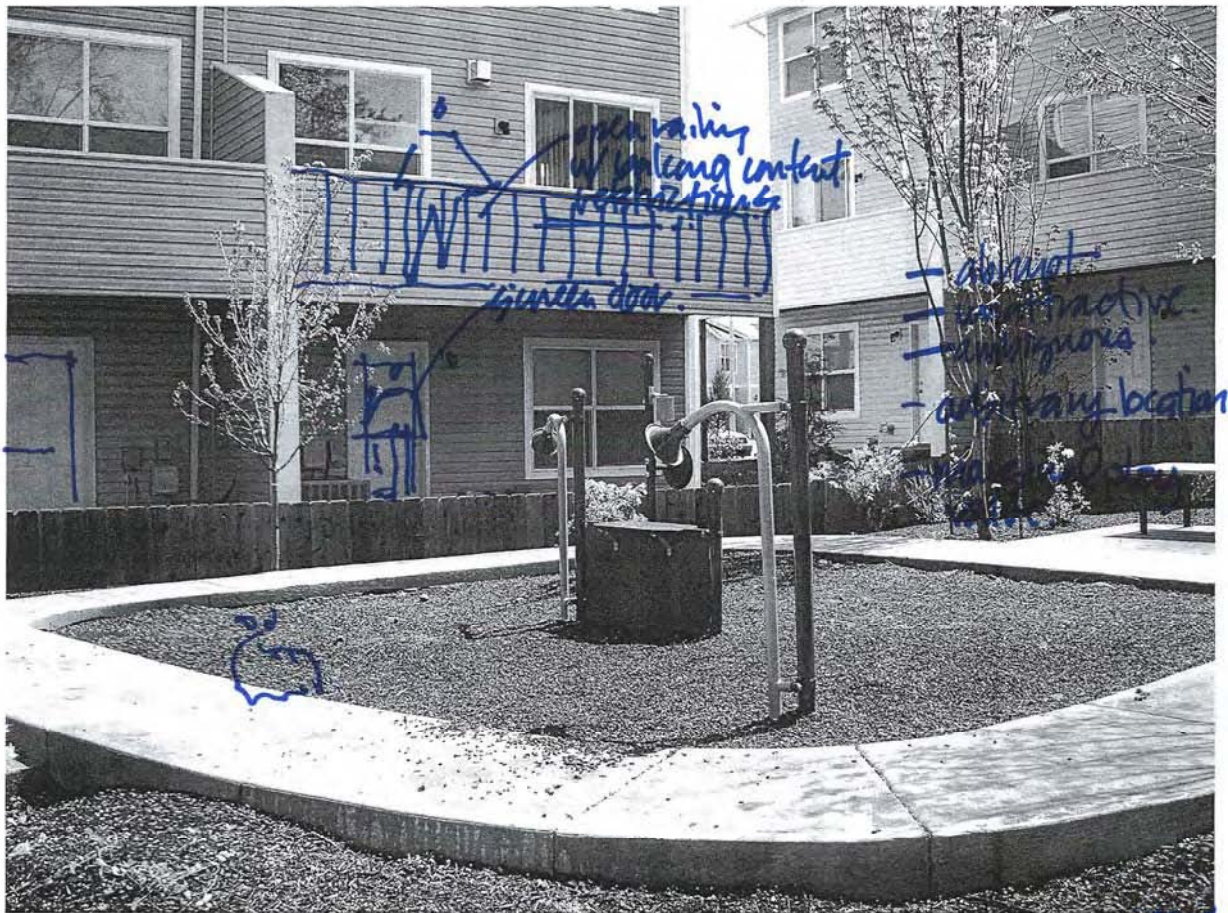
- The play area is abrupt, unattractive, and ambiguous and is located in an arbitrary location and offers a marginal play value.
- Open space areas should have visibility which can be accomplished using screen doors and open railings for balconies.
- Balcony content should be regulated as well.

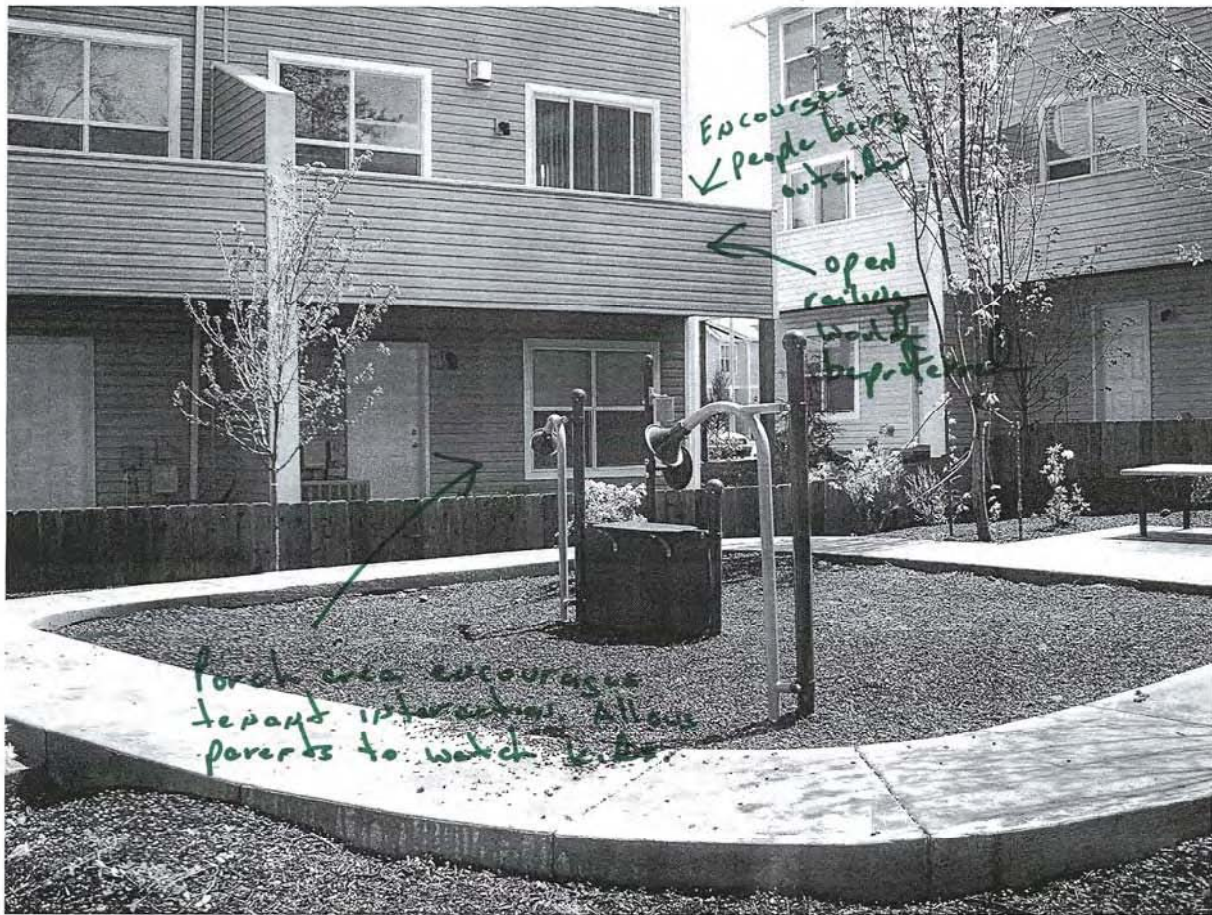
- The porch area encourages tenant interaction and allows parents to watch kids.

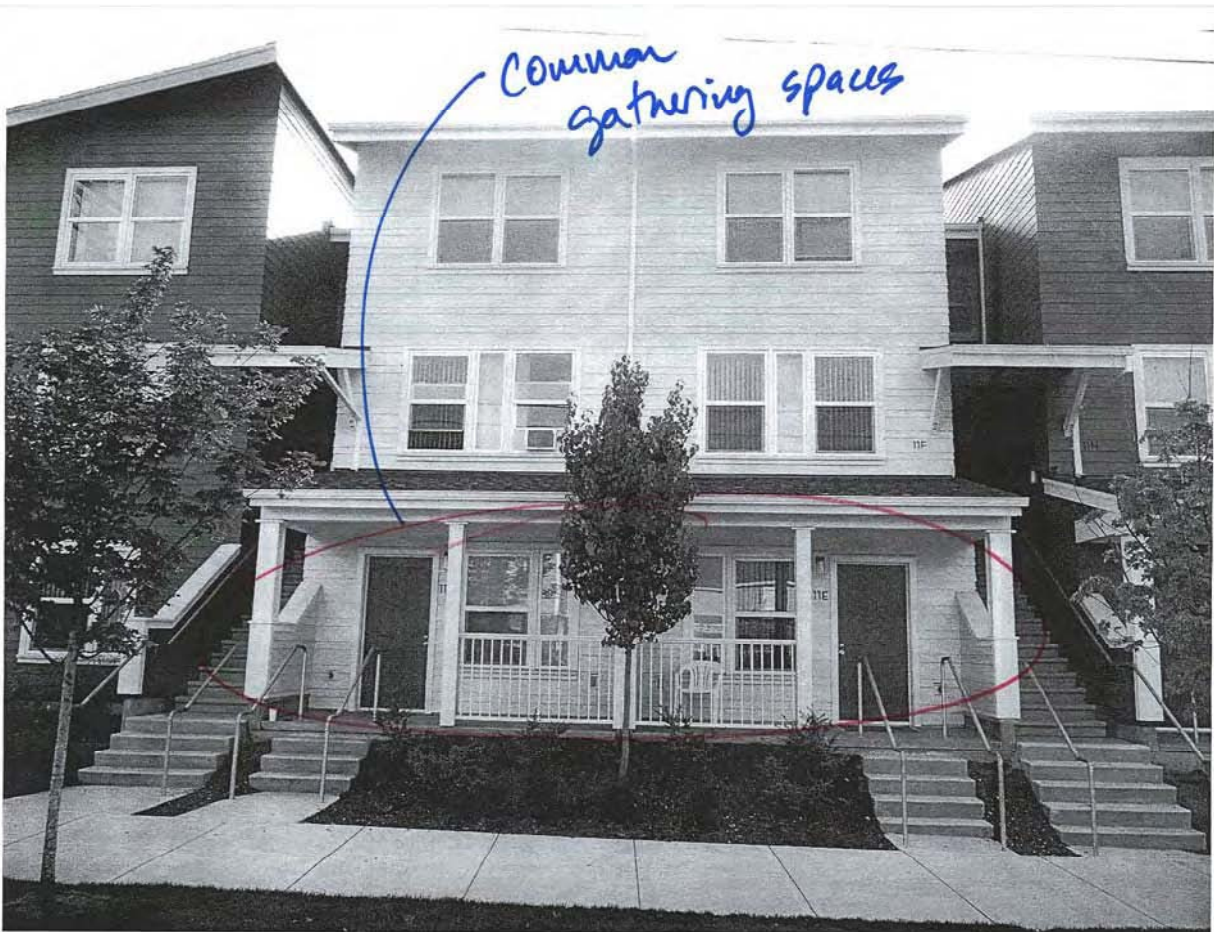
- Common gathering spaces are present.

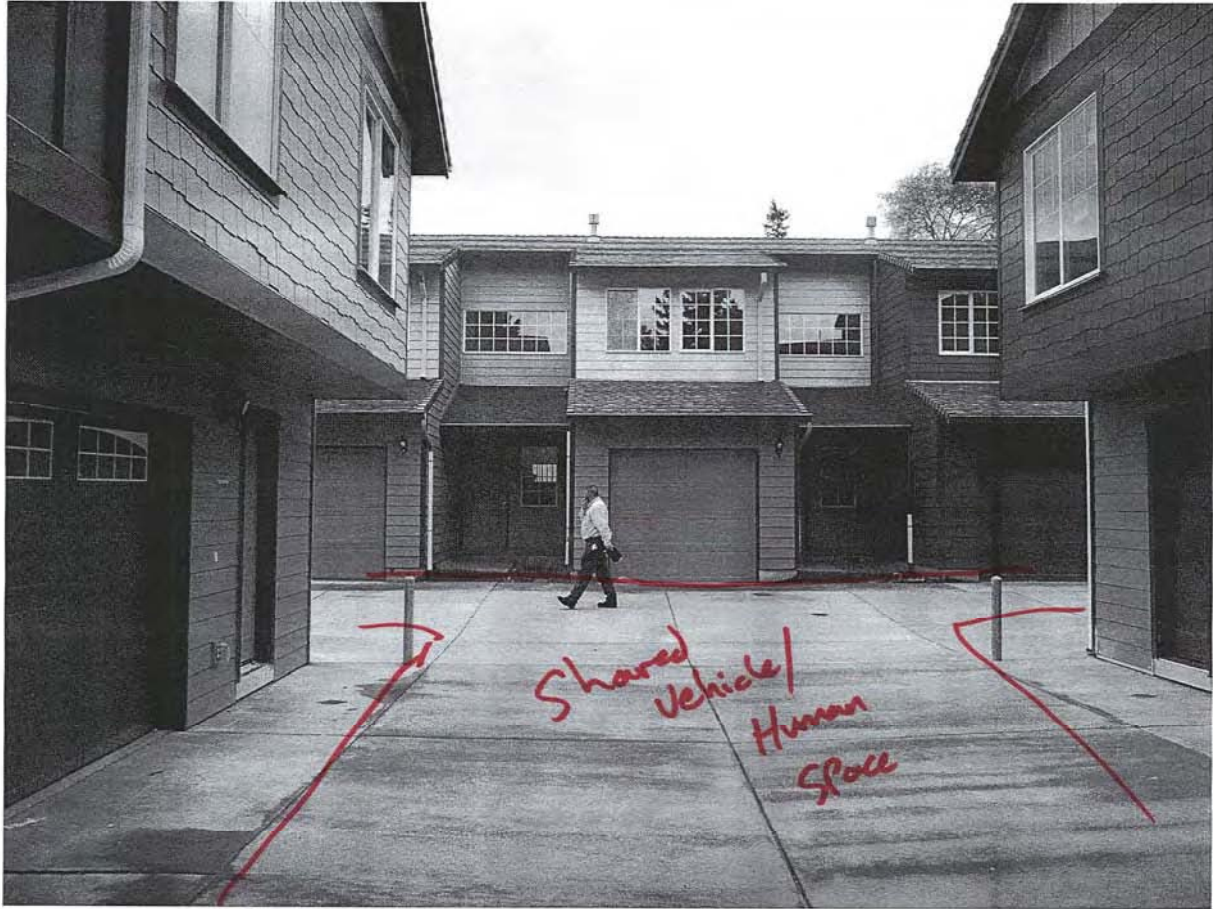
- This is a shared vehicle/human space.
